Structural appraisal of climate-induced effects on E. Torroja's unreinforced brickwork shell structure of the IETcc winter garden

O. Río (*), D. Theodossopoulos (**)

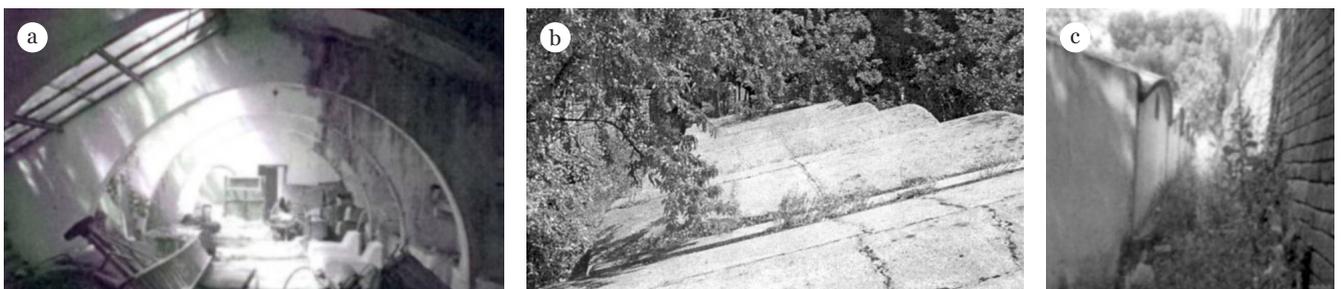
Regarding the masonry arches, they present a main crack that runs primarily through the whole cross-section off the keystone towards the north wall and other smaller ones in the area in between. Although they appear in all the arches, their size and especially width is decreasing towards the west end (Figure 4a). Similarly, the extent of the damage due to moisture penetration decreases when moving from east to west.

Figure 4. Aspect of the interior (a) and exterior (b) of Winter Garden and (c) surrounding area in 2008.

As far as the deformation of the arches is concerned, the asymmetric crack pattern is due to the higher weight of the vault (at the N side in Figures 4a and 7a) and the water ingress that has caused the decay of the mortar joints next to the spandrels. There may also be more complex interactions between the arches and the vaults and a more detailed analysis of the behaviour is carried in the next section in order to get more insight to the distribution of the loads.

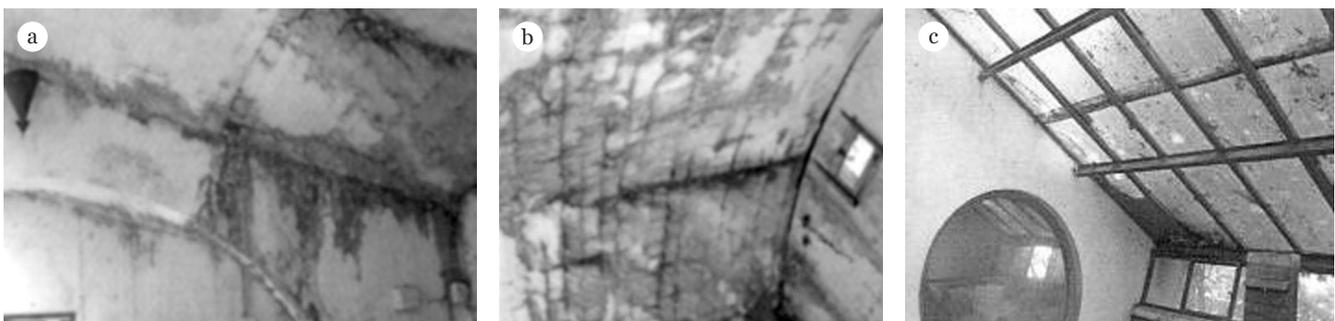
As mentioned, the building went through a long period of neglect. The result was a deterioration of the roof's waterproofing (Figure 7a and 7b) and some corrosion of the metal frame of the glazing (Figure 7c). There is a clear presence of dampness at the fabric, especially towards the back side, probably accelerated by lack of maintenance of the gutters. The pattern of these cracks and the effect of the moisture decreases along the axis of the building in the East-West direction, towards the area of the natural land fill.

So far as the roof barrel vaults are concerned, they present cracks along the east-west axis mainly on the north half of the vault (Figure 7b) as also perpendicular cracks located next to the arch elements (Figure 7a) and along the main axis of the vault. Similar to the arch damages, their size decrease towards the west end of the building. Moisture damage follows the crack pattern but does not decrease so much, and is greater on the middle vault, being more pronounced as cracks at the mortar joints.

corner of windows at ground settlement, only appear on the bays located on the eastern part of the building (Figure 7b).

No significant damages were observed on the structural elements near the windows with the exception of those where the south wall joined the glazing (Figure 7c). A large number of glass panels were broken; the steel structure had deteriorated and water tightness sealant was nonexistent. The doors and window frames of the north wall also showed damage signs.

The degradation of the joints at the vaults led to water ingress to the arches and the weakened bond between the bricks caused cracks on the vaults and hinges at the crown of the arches towards the spandrels and the back side, partially buried in the natural slope. There are some pronounced cracks in the longitudinal axis of the shells (Figure 7b) and spread is prevented probably due to the mutual constraint of the adjacent bays along the arches (Figure 2) and the diaphragm action at the back. Transverse (hoop) cracks are

also apparent, mainly along the bed joints of the brickwork (Figure 7b) but the extrados also shows a series of cracks, also closer the longitudinal apex (Figure 7a).

Figure 7. Examples of damages observed: a) on the first or easternmost arch, b) on the bay 3 vault and (c) their N wall.

The deformation of the vault spreads further into the arch and the area of the crown deforms relatively higher. The distribution of the radial stresses (S11 in Figure 9) shows higher tensile forces in an area that coincides with the location of the main cracks, as they appear in Figure 7a, therefore it is reasonable to justify the damage observed.

The understanding of the crack pattern and the dynamics of deformation permitted the planning of the strengthening works in the essential areas, as part of the rehabilitation of the building. At the start of the works, the entire brickwork was stripped down completely from the render and this allowed the crack pattern to be better surveyed. Then, all the mortar joints were scraped in order to ensure that all degraded material was removed. All minor cracks were filled and the joints were repointed. The major structural repair was to stitch the main crack in each arch using a plate in the direction that the hinge is expected to open (Figure 10).

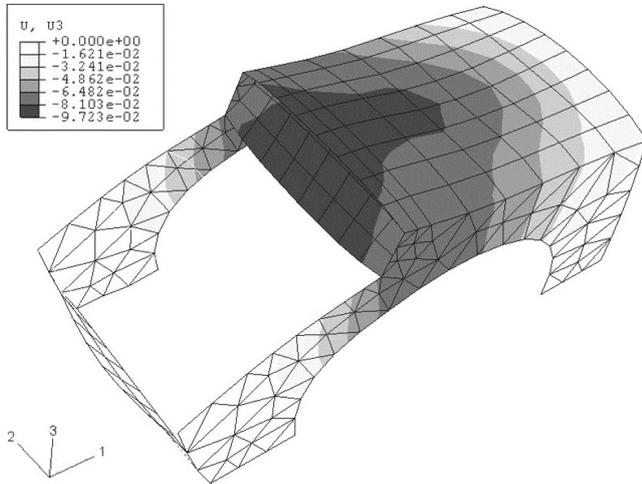
The analysis shows the high reserves in strength of the form under the ideal conditions considered here. The deformation of the model in Figure 8 shows a higher concentration of vertical displacement at the inner end of the vault, above the lintel of the window, but the values are overall small, to a maximum of 0.1 mm. A study of the distribution of the stresses at the extrados of the vault (Figure 9) shows the middle strip of the vault cantilevers towards the window (axial tensile stresses S11 at both ends), while in the hoop

Figure 8. Deformation and deflections of the FE model for bay 3 (in mm).

The degree of safety is quite large, as also the serviceability margins (0.1/3080, compared to acceptable limits of 1/250). It is unlikely therefore that failure can occur due to excessive weight on the structure, whether dead or imposed load (like snow or blocked rainwater). Small cracks under these conditions are possible however at the areas of maximum tensile forces and lack of maintenance means that rainwater may enter through the cracks at the intrados and moisture can build up. Atmospheric actions therefore like freeze/ thaw cycles and temperature variations can cause the cracks to spread, following the joints. The vaulted structure would have slowly weakened along the edges and the crack from the arches would have slowly spread in the hoop direction of the vault, splitting it into two segments that, together with the degradation of the bed joints, would further degrade into a series of rings, as can be seen today.

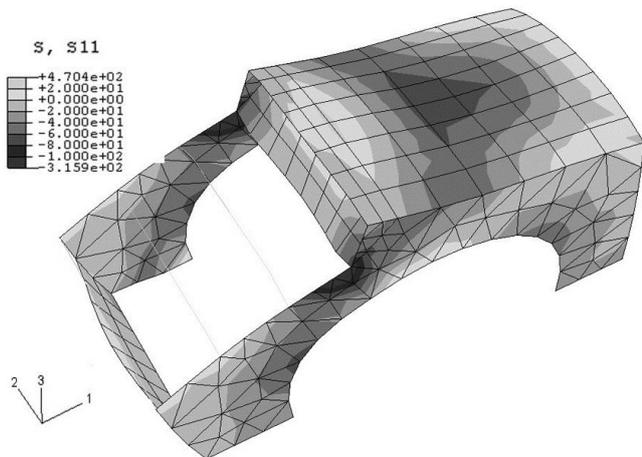
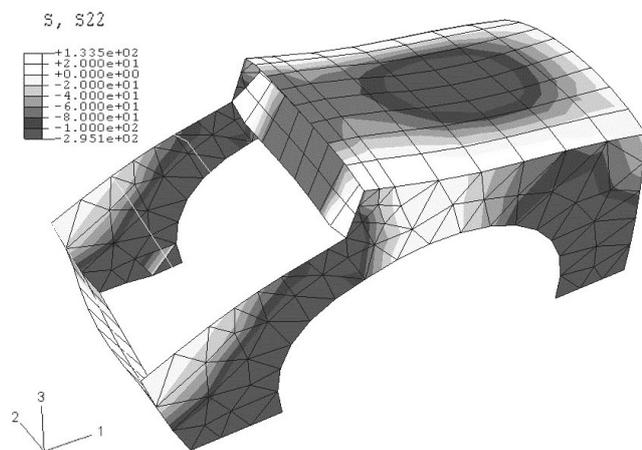
Figure 9. Loads at the extrados of the vaults in bay 3 in the axial (S11) and hoop direction (S22) in kN/m². Stresses S11 have a radial direction in the case of the arches.

direction (S22) the tensile forces appear along the edge with the arches. The latter tensile forces are higher along those edges and this is where the cracks are expected to start if a high load is considered to act. The overall values however are small (maximum 130 kN/m² or 0.13 N/mm² in the hoop direction), while max compressive stresses are about 0.3 N/mm², i.e. well below the assumed strength.

The structure sits also on the slope so differential movement could have destabilised the containment of the bays in the longitudinal direction, as also the changes in the crack pattern show. Settlement could have also increased the deformation around the windows of the wall in bay 3 (Figure 7b), which could have originated from the detachment of the vault from the wall (S11 in Figure 9).

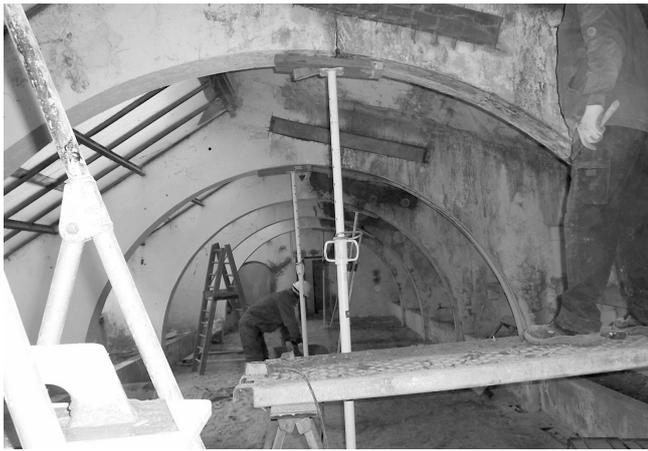
Figure 10. Preliminary stage of repairing and cleaning.

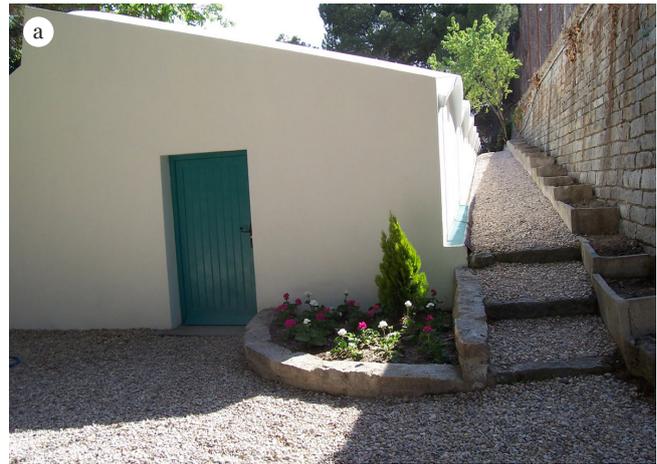
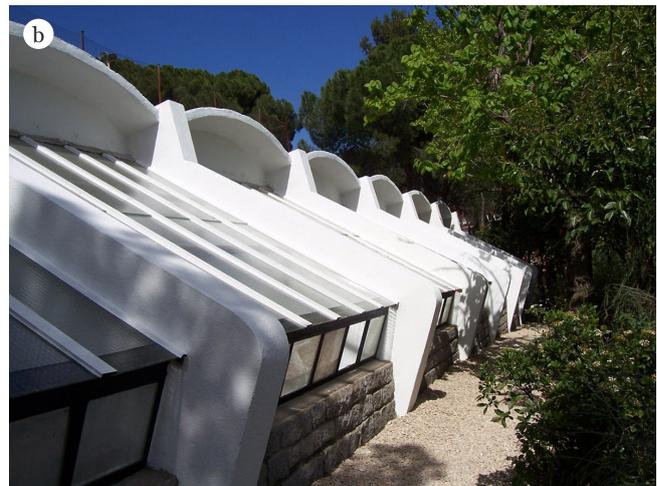
Figure 11. Aspect of north east face (a) and of glazing south elevation (b) after finishing refurbishment works.

The surrounding areas were cleared from overgrowth and the planting bays close to the wall were removed, while all drainage was refurbished. Once the integrity of the structure was restored, thermal insulation and a waterproofing screed was applied on the vaults and the timber doors were restored

(Figure 11a). In the interior, a new single-coat render was applied. So far as the metal frame of the windows is concerned, all the mullions were cleaned and the glass panels that had not been damaged were placed once again. The damaged ones were replaced with reinforced glass that was distinct from the original panels and for this reason two entire bays were glazed this manner (left bay on Figure 11b). In addition, the most damaged metal mullions were protected from the ingress of water. Eventually, the building at the end of the works is once again the very pleasant multi-functional space that was planned originally (Figure 12).
