A protocol for using unmanned aerial vehicles to inspect agro-industrial buildings

Javier Gómez (*), Alberto Tascón (**)

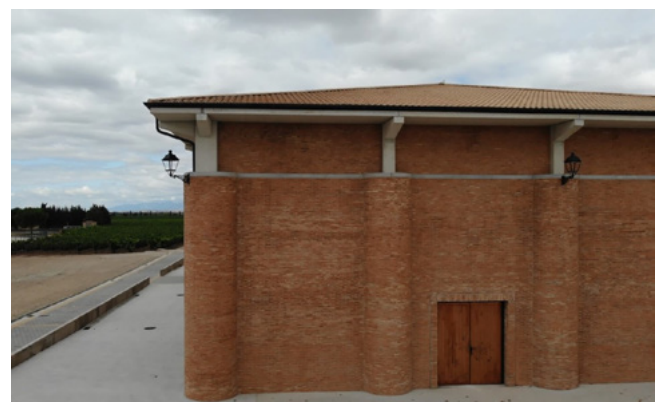
The inspection flights provided videos of both visible and thermal images covering the entire building envelope. These videos were used for confirming correct execution of the construction work. The amount of data generated during this study was approximately 50 Gb for the visible images and 780 Mb for the IR images. Figure 6 shows one image of the building envelope extracted from the video taken by the drone during the first inspection flight. Similarly, Figures 7, 8, 9 and 10 collect several IR images recorded by the drone during the second inspection flight; in all these figures camera level and span are shown at the bottom. As illustrated in Figures 8, 9 and 10, the drone's thermal camera detected temperature differences in some envelope elements. These differences were analysed to ensure that they were not due to faulty insulation installation or any other construction error, by following the general principles for qualitative thermographic examination in standards and handbooks (10, 22). However, it is important to remark that thermal images interpretation involves a high level of subjectivity and mainly relies on the expertise of the human operator, as pointed out by Garrido *et al.* (23). For that reason, some research has aimed at developing methods for automatic detection and characterisation of thermal bridges (23, 24).

Figure 6. Image of the building envelope taken by the drone during the first inspection flight.

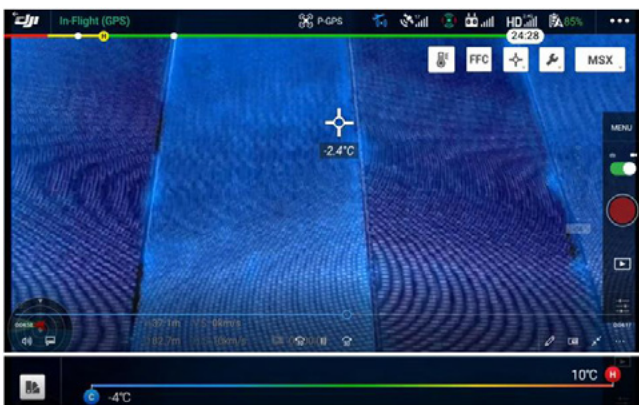
The inspection revealed that the building envelope had been correctly executed and that insulation uniformity was excel-

lent in walls and roofs alike. For example, Figure 7 illustrates the absence of thermal anomalies in the building roof. The drone's thermal camera detected some temperature differences where this was to be expected, i.e. elements that were less insulated than the rest, such as windows and doors (Figure 8). Also, the flue that extracted air from the barrel washing room, whose temperature was much higher than the outdoor air temperature, was clearly identified (Figure 9).

Figure 7. Thermal image of the roof taken by the drone.

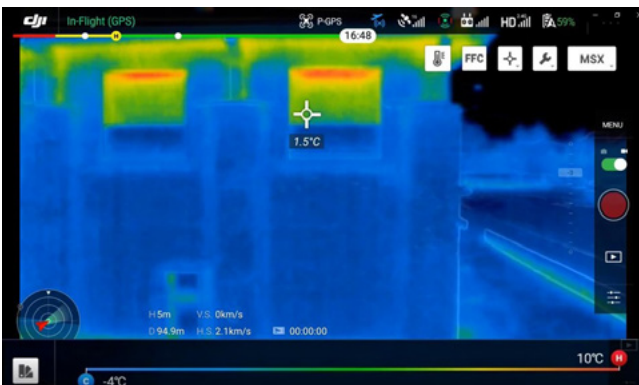
Figure 8. Temperature differences detected by the thermal camera: Windows and door.

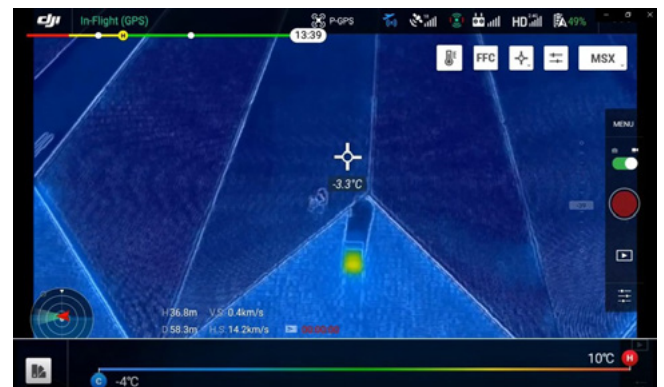
Figure 9. Temperature differences detected by the thermal camera: Flue in the roof.

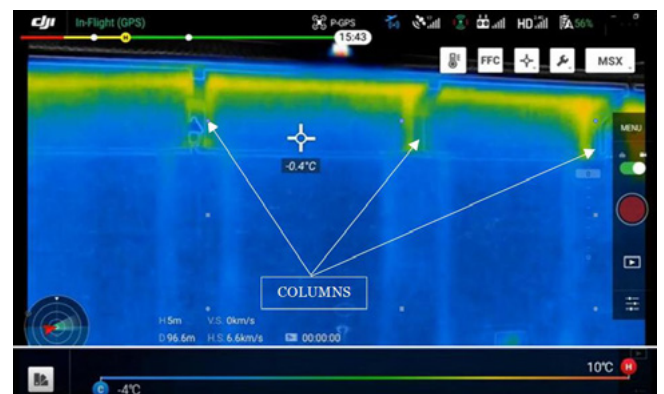
Figure 10 shows that the underside of the eaves and the upper region of the side walls were warmer than the lower part of the walls; this can also be seen in Figure 8. This phenomenon can be explained by the effect of the roof overhang on the clear sky radiant cooling rate (10): the warmer elements had sustained less radiative losses during the night because of their angles to the zenith, 180° and 90° , respectively.

Vollmer and Möllmann (10) demonstrated that clear night sky radiant cooling can generate a difference of 8°C between horizontal surfaces covered with aluminium foil – which reduces radiative losses – and uncovered surfaces facing the sky, or a difference of 6°C in the case of vertical wall surfaces. They even detected an area on part of a wooden house wall below a carport roof that was 3°C warmer than unprotected areas of the wall, only 4 hours after sunset; their experiment was quite similar to the situation reported here, with the difference that the UAV was flown at dawn, i.e. when the period of time for energy loss from the walls of the agro-industrial building was much longer. Therefore, the temperature differences recorded below the eaves (5.1°C between the hottest and the coldest spots) could be explained by this phenomenon. However, it is obvious that

there is also a geometrical thermal bridge along the joint between the wall and the eaves; this kind of thermal bridge is unavoidable and is not related to either defective insulation or poor construction design. Another possible reason for these temperature differences is air leakage from the building to the inner space between the horizontal eaves and the roof slope.

It is important to note that the temperature differences observed below the eaves could be the result of a combination of several phenomena, as explained above, but it is not possible to determine the exact contribution of each one by means of an external qualitative IR survey. Further information could be obtained by carrying out an internal IR survey or by taking photographs from the drone at a shorter distance at different times and at different outdoor temperatures. To analyse this thermal anomaly in more detail, it would be necessary to carry out further in-depth studies, such as contact thermometer measurements to correct apparent temperatures (25), quantitative IR methodologies (26-28), computer simulations (29) or air infiltration tests (30, 31).

Figure 10. Thermal image of the southwest wall taken during the second inspection flight.

In addition, Figure 10 shows that the upper parts of the concrete columns, which were partially exposed, were warmer than the wall. Since the columns were located between the precast concrete panels, as can be seen in Figure 11, this temperature difference can be explained by the fact that the columns did not have any insulation at all, whereas the concrete panels had a core made of insulation material. Thus, heat could easily flow through the concrete columns. Figure 11 illustrates the heavy insulation (rock wool, air chamber

Another point can be added to the reasons already given above to explain the thermal anomalies shown in Figure 10. The properties of the different construction materials – particularly their emissivity values – influence the quantity of IR radiation emitted. Both the eaves and the columns were made of reinforced concrete, whereas the outside walls consisted of brick cladding. These two materials have different emissivity ratios: 0.94 and 0.90, respectively (32).

The IR-UVA inspection did not reveal any relevant defects in envelope execution. However, two thermal anomalies – below the eaves and along the upper part of the columns – were detected and should be followed in time. It is well-known that critical thermal bridges can lead to condensation and mould growth (28).

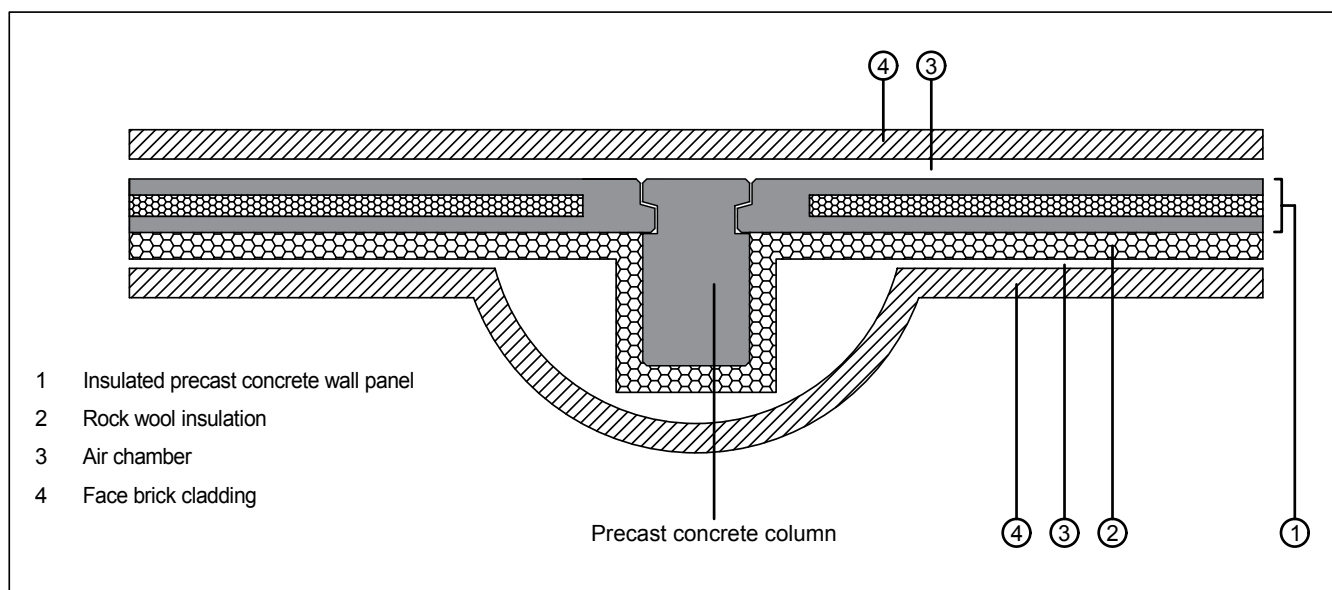
and brick cladding) that covered the exterior side of the wall panels and also surrounded the columns up to 7.20 m high, as can be seen in Figure 6. However, these insulation layers did not cover the upper parts of the columns because of aesthetic criteria and the need to rest the eaves on the column brackets. Consequently, the thermal anomaly recorded did not indicate a defect in envelope execution, but rather a thermal bridge associated with the design of the structure and envelope system. Considering the volume of the building and the total surface area of its envelope, this thermal anomaly was not considered important. Nevertheless, this information could be employed in future projects to rethink and improve this kind of structures in order to design more energy-efficient buildings.

Figure 11. Cross section view of the wall at 1.00 m high
