A building characterization-based method for the advancement of knowledge on external architectural features of traditional rural buildings

S. M. C. Porto (*), [G. Cascone](#) (*)

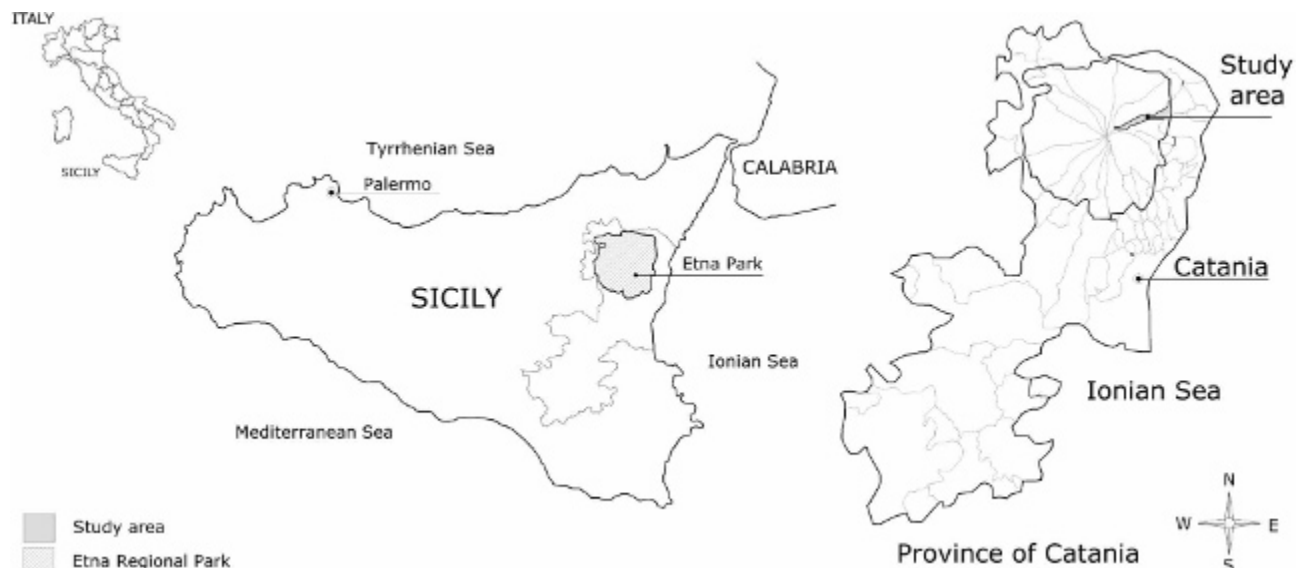
1. Localization of the study area within the Etna Park (Province of Catania, Italy).

The rural buildings considered in this study (Figure 1) are located in an area which has an extension of about 818 ha and is entirely

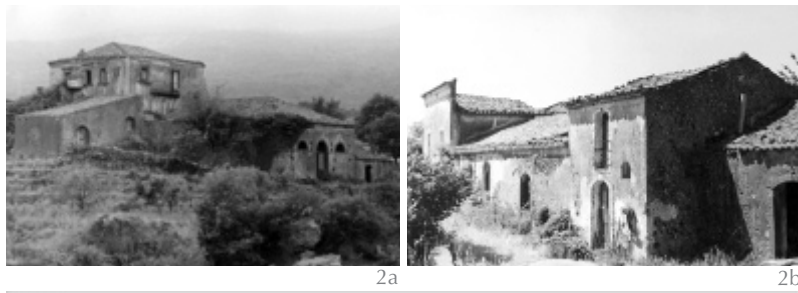
2. (a) Landowners' house and specialized buildings used for wine production; (b) Traditional rural dwellings.

- Functional destinations: rural dwellings and specialized buildings, mainly devoted to wine production (Figure 2).
- Building materials and techniques: e.g., lava stone masonry for the bearing structure, baked-clay tiles for roof covering, traditional plaster characterized by mortar lime and *azolo* for the surface finish of the façades, chestnut wooden purlins and rafters for the bearing structure of roofs.
- Building typologies: aggregation of basic functional types identified in a previous study (31) (Figure 3).

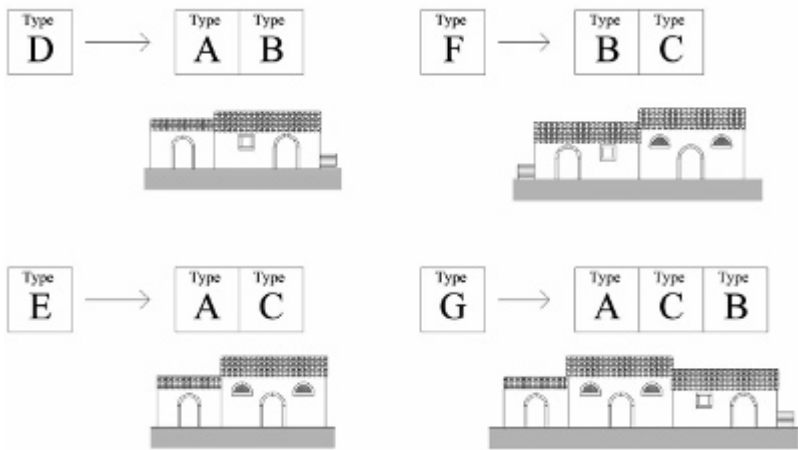
6. Linear aggregations constituted by juxtapositions of the basic functional types.

Nine buildings, that represent 36% of the surveyed buildings, were juxtaposed buildings that were classified as shown in Figure 6. Only one building appertained to type-D, which derived from the linear aggregation of type-A (dwelling) and type-B (*palmento*); another building belonged to type-E, which was a result of the linear aggregation of type-A (dwelling) and type-B (wine-cellar); three buildings were classified as type-F, which resulted from the linear aggregation of type-B (*palmento*) and type-C (wine-cellar); and four buildings belonged to type-G, deriving from the linear aggregation of the three basic functional types.

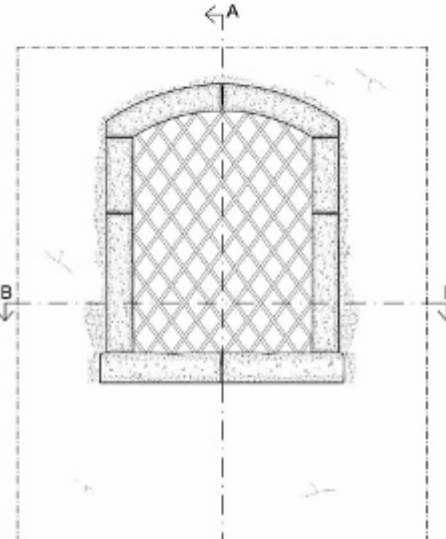
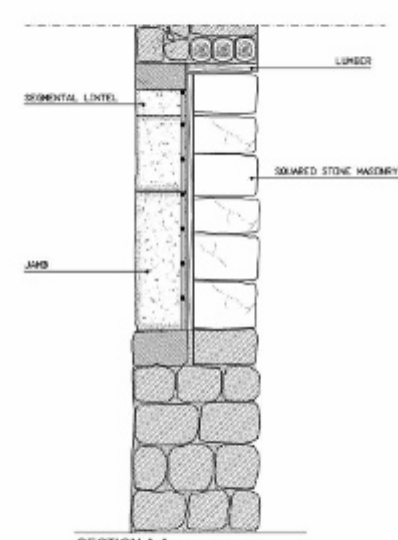
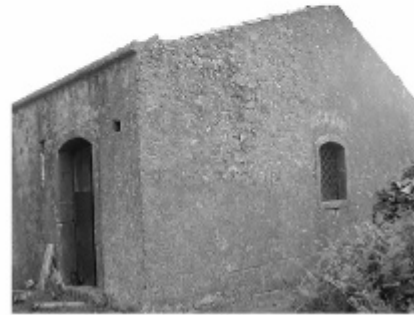
Technical Card Ws1

12. An example of the technical card that illustrates the external architectural feature Ws1.

The horizontal structure, that supports the weight of the masonry placed above the openings, is divided into two parallel structural elements: an external and an internal lintel. The external lintel was built by using stone blocks and took a segmental-arch form. The internal lintel was built by placing a number of wooden beams above the jambs or a wood plank. The beams had a circular cross-section (section of the rustic wood, 0.12 m) and their number depended on the thickness of the wall.

- 1) increased porosity of the stone materials induced by temperature ranges;
- 2) wind abrasion;
- 3) salt efflorescence produced by capillary rise of groundwater and subsequent evaporation;
- 4) biodeterioration determined by the activity of microscopic organisms, animals or vegetables;
- 5) cracks created by seismic events or overloads.

took a segmental-arch form in the case of Ws1 (Figure 12) and Ds1 (Figure 13) opening types, and a flat-arch form in the case of Wf1 and Df2 opening type. The internal lintel was built by placing a number of wooden beams above the jambs or a wood plank. The beams had a circular cross-section (section of the rustic wood, $\varphi \cong 0.12$ m) and their number depended on the thickness of the wall.

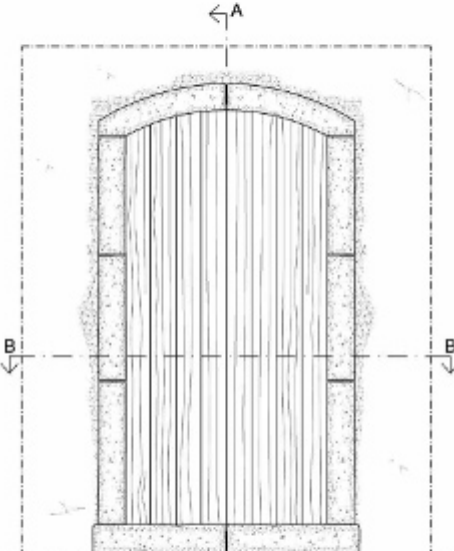
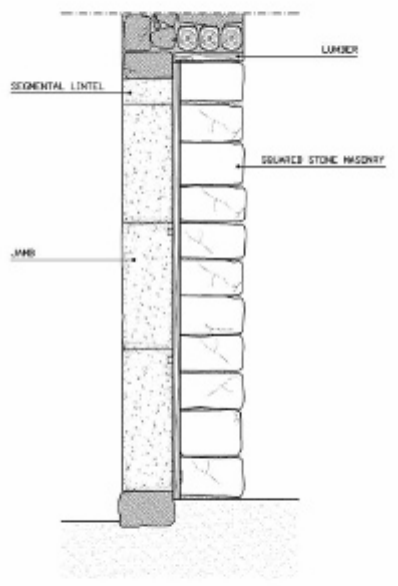
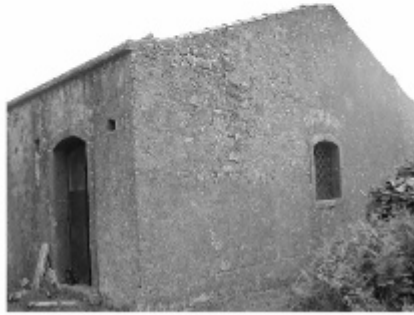
Technical Card Ds1

13. An example of the technical card that illustrates the external architectural feature Ds1.

The horizontal structure, that supports the weight of the masonry placed above the openings, is divided into two parallel structural elements: an external and an internal lintel. The external lintel was built by using stone blocks and took a segmental-arch form. The internal lintel was built by placing a number of wooden beams above the jambs or a wood plank. The beams had a circular cross-section (section of the rustic wood, 0.12 m) and their number depended on the thickness of the wall.

- 1) increased porosity of the stone materials induced by temperature ranges;
- 2) wind abrasion;
- 3) salt efflorescence produced by capillary rise of groundwater and subsequent evaporation;
- 4) biodeterioration determined by the activity of microscopic organisms, animals or vegetables;
- 5) cracks created by seismic events or overloads.
