A comparison of the resistance of Temporary Edge Protection Systems to static and dynamic loads

M. N. González (*), A. Cobo (*), A. Castaño (*), M. I. Prieto (*)

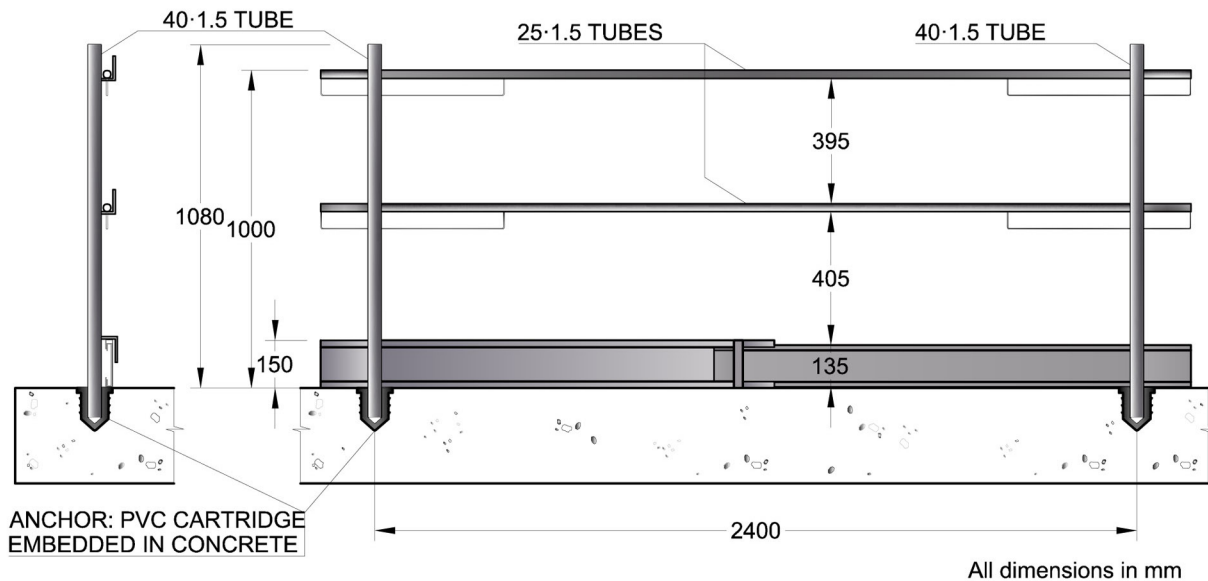
The seven systems were anchored to a reinforced concrete beam into which PVC tubes had been embedded to house the circular section vertical posts. As an example, Figure 1 shows the layout and the geometric characteristics of test system 1.

Figure 1. Geometry of system 1.

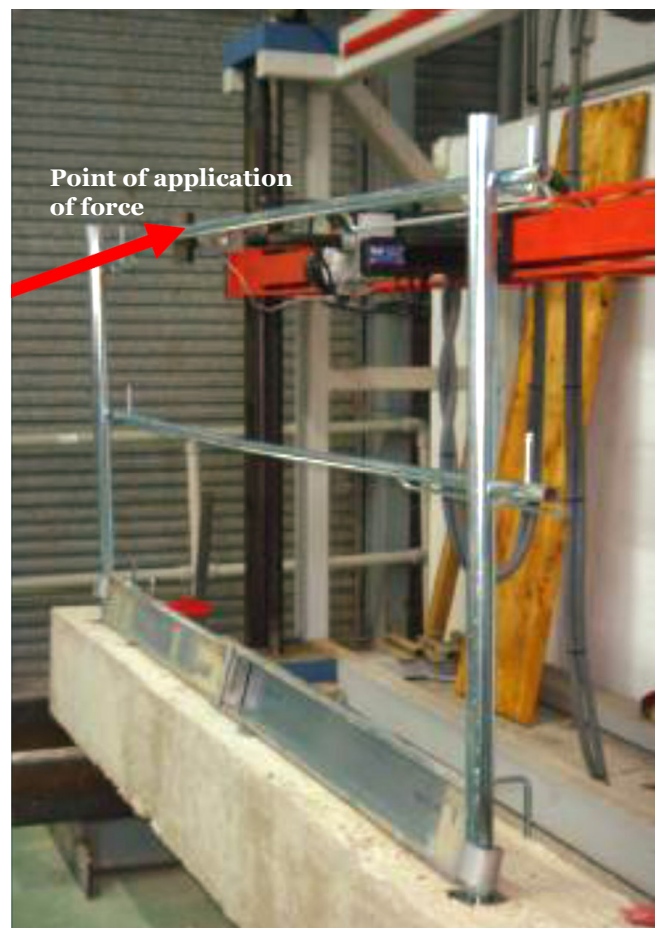
Figure 2 shows the set up for the deflection tests on the upper guardrail of system S2.

Figure 2. Deflection test on the upper guardrail of system S2.

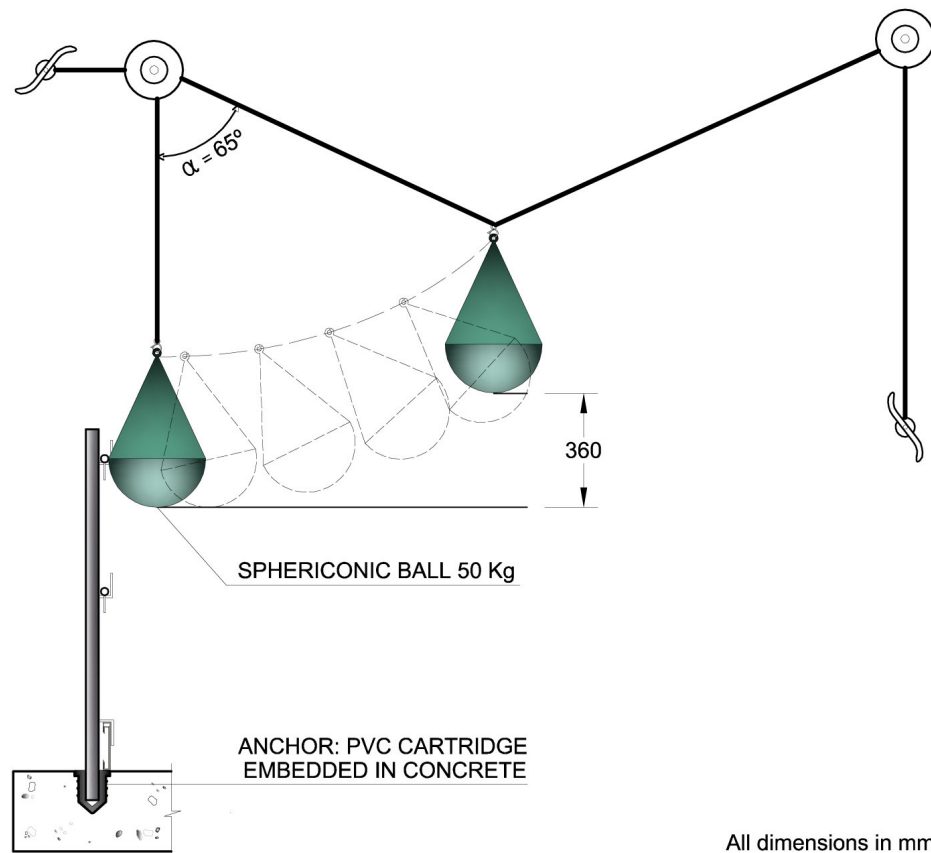
(28) from the necessary height, so that the energy of the impact would be equal to 180 J ($180 \text{ J} / 500 \text{ N} = 0.36 \text{ m}$) (Figure 3).

Figure 3. Impact test at $E = 180 \text{ J}$.

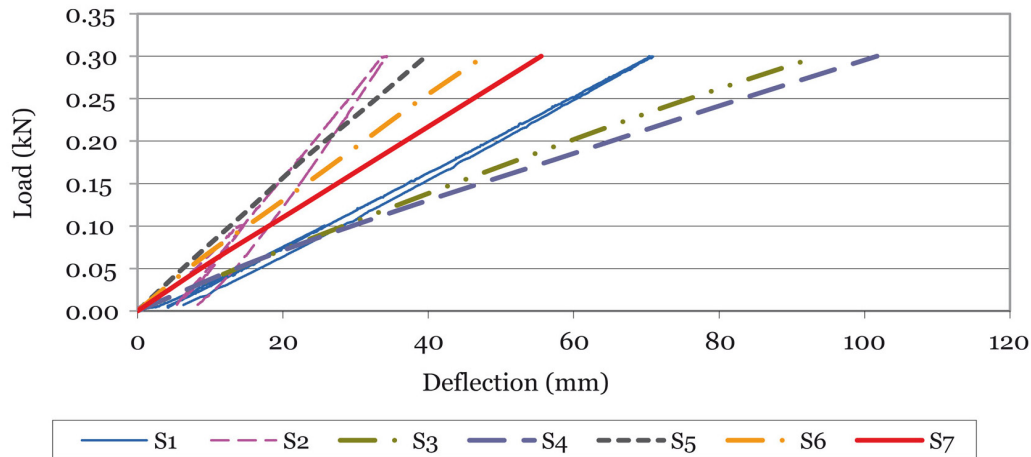
In Figures 4 and 5, the results corresponding to the deflection and strength tests are shown when the load is applied to the central point of the main guardrail.

Figure 4. Results of the deflection test. Load applied to the central section of the main guardrail.

It may be confirmed from Figure 4 that the behavior during the deflection test on the 7 systems is practically elastic and linear. The differences in guardrail rigidity are evident from the different slopes of the respective diagrams.

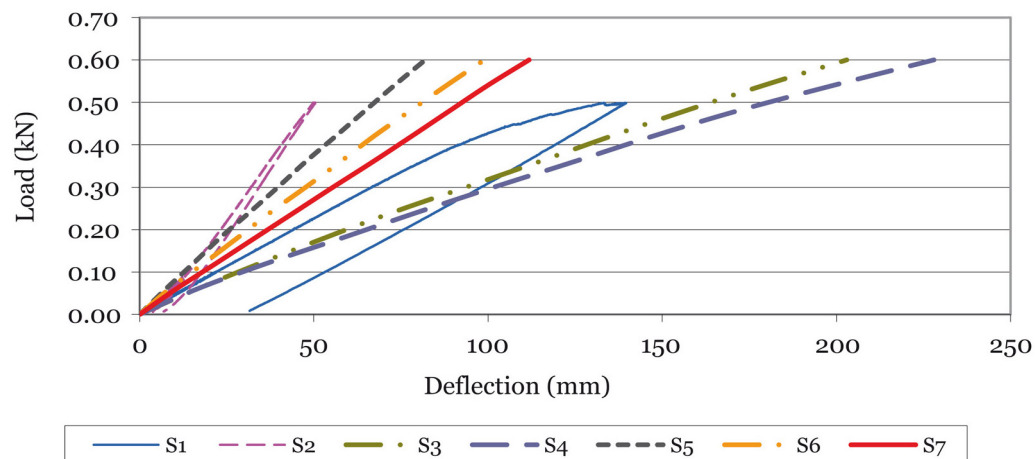
Figure 5. Results of resistance test. Load applied to the central section of the main guardrail.

Figure 5 once again highlights the different rigidities of the three systems. In system 1, the diagram is approximately linear up until a load of 0.40 kN, from that point the linearity is lost and the movements grow more rapidly than the forces, slowly losing system rigidity, as a consequence of the plastic deformation that is occurring in the system. When reaching maximum loading and unloading, the unloading takes place along a parallel straight line to the application of the loads and a residual deflection is left of approximately 30 mm (30.07 mm). In this case, the system resists the maximum test load, but does not comply with the other two requirements of the standard: residual deflection is 10 % above the instantaneous maximum on the main and intermediary guardrails and ultimate resistance (0.57 kN) is not more than 1.2 times the maximum test load of 0.60 kN, (Table 2 and Figure 5).

The behavior of systems 2-7 is linear, with practically no observable deformation remaining. The three points indicated in the standard for satisfying the resistance requirement were all satisfied (Table 2 and Figure 5).

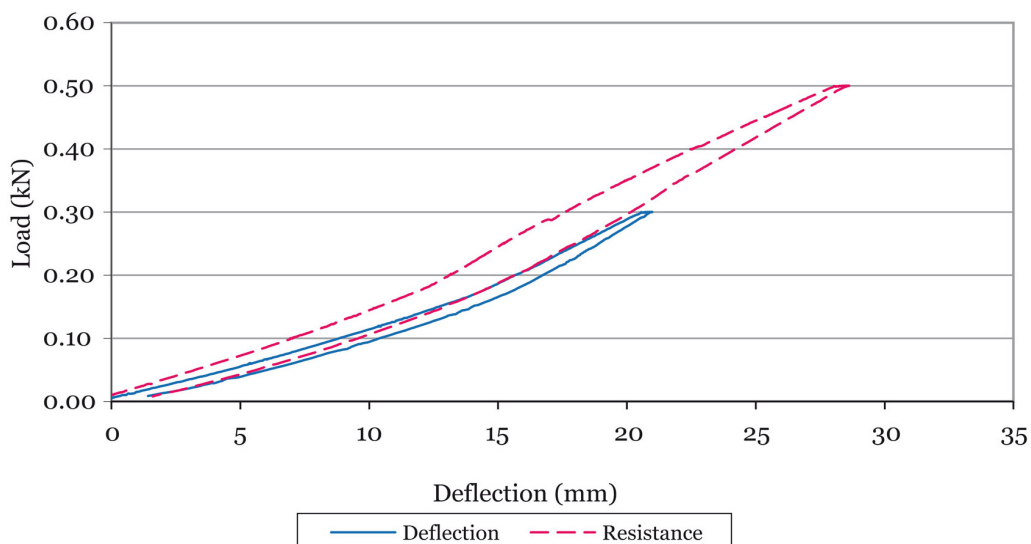
Figure 6 shows the results of the deflection and resistance tests on vertical post P1 when the load was applied to its upper end.

Figure 6. Results of the deflection and resistance tests. Load applied to the upper section of the vertical post.

The load-deflection curve corresponding the deflection test for post P1 (Figure 6) initially showed anomalous behavior, as a consequence of non-linear deformation of the PVC tube when the load was applied, which produces a non-linear graph reflecting rigidity under loading. The behavior is linear, once approximately half the test load has been applied. Unloading takes place in an elastic way, very approximately in line with the curve that reflects the load. A movement below the limit permitted by the standard was obtained.

In the load-deflection graph corresponding to post P1 during the resistance test (Figure 6), anomalous behavior was once again evident as the load increased, with an increase in the rigidity of the system, caused by deformations between the PVC tube embedded in the concrete beam and the metallic vertical post. When these deformations ended (at approximately 0.20 kN), behaviour corresponded to the rigidity of the post. The maximum test load having been reached, unloading occurred in a similar way to loading, which means that the deformations in the PVC tube recovered and the behavior of the vertical post was elastic. The vertical post passed the resistance test.

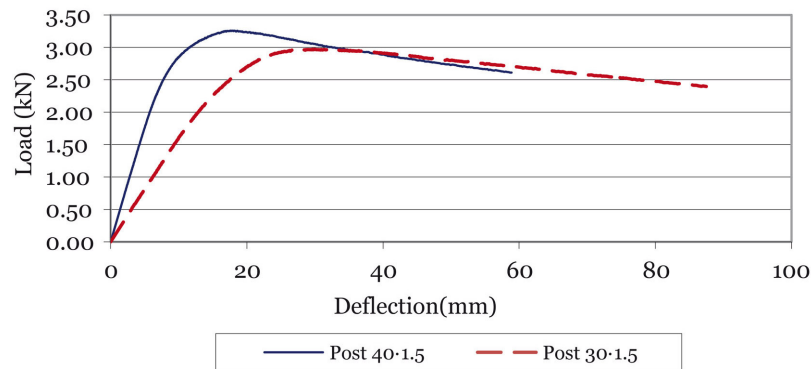
Figure 7. Load-deflection diagrams of the vertical steel posts applying increasing loads at their upper ends.

Figure 7 shows the load-deflection diagrams obtained from vertical posts P1 and P2 when increasing horizontal static loads were applied at their upper ends.

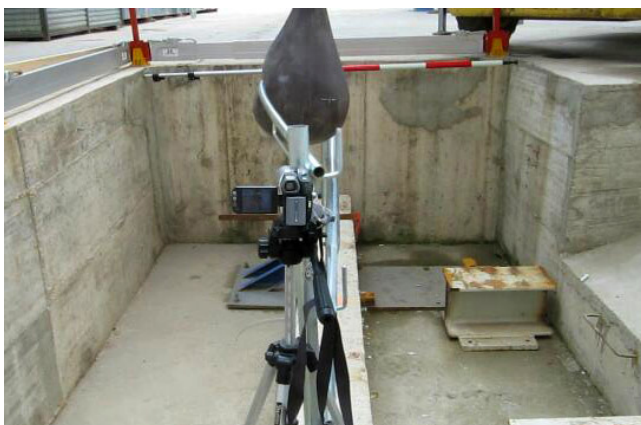
The principal guardrail of system S1, after the impact (Figure 8), experienced plastic deformations following which its geometry as indicated in Figure 9, had an excess deflection of 115.01 mm, which meant an 11° rotation in the plastic hinge.

Figure 8. Maximum deflection of the S1 guardrail at the time of impact.

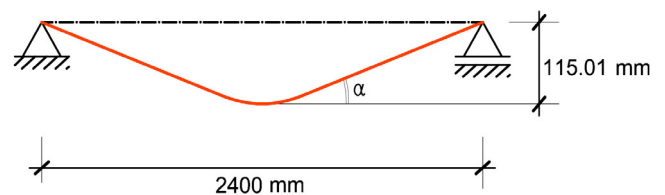
Figure 9. State of S1 guardrail after the impact.

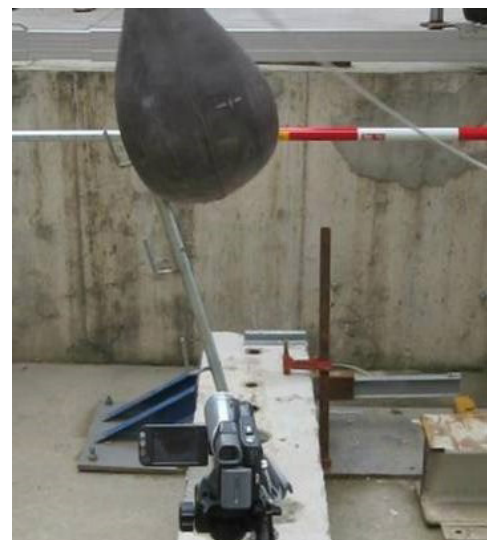
When the impact of $E = 180 \text{ J}$ occurred at the upper end of vertical post P1, the pole underwent plastic deformation at the height of its attachment to the structure, having a residual deflection of 61.05 mm and a permanently bent angle with regard to the vertical of 3.5° . In the case of post P2, the permanent deformations were larger, leaving a residual deflection of 104.53 mm, which meant a rotated angle of 6° . Both posts withstood the ball at the time of its impact (Figures 10 and 11).

Figure 10. Maximum deflections produced in vertical posts P1 and P2 following the impact.

It can be experimentally confirmed that both vertical posts were able to withstand the impact and what is more, the displacements obtained after the impact were very similar to the maximum displacements obtained during the static test (Table 3 and Figure 10).

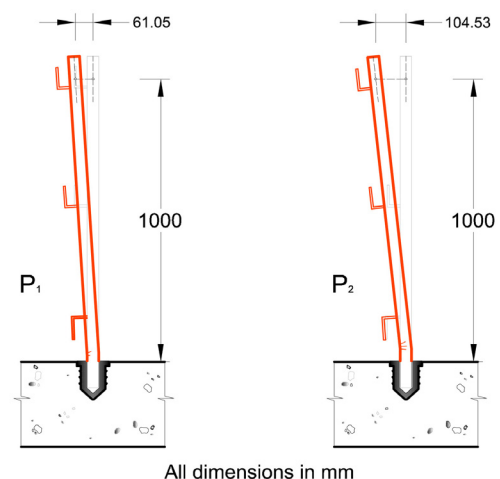
Figure 11. Permanent movements of vertical posts P1 and P2 following the impact.

Analysis of the load-deflection diagrams of the vertical posts 40-1.5 and 30-1.5 in Figure 11 reveal a more rigid behavior up until the maximum test load of the vertical post 40-1.5. Having reached the maximum test load, both vertical posts underwent a drop in resistance until the end of the test. It should be noted that there is no period of plastic yield after reaching the maximum load, as might be expected due to the behavior of the steel. The difference is because when the maximum test load is reached and the piece continues to be deformed, a modification in the geometry of the section under greatest pressure takes place, leading to local buckling and reducing the resistant moment and the inertia of the section. Figure 12 shows the section under the greatest stress of a tubular section subjected to a flexural test. It may be seen that local buckling in the section implies a reduction in its resistant moment.

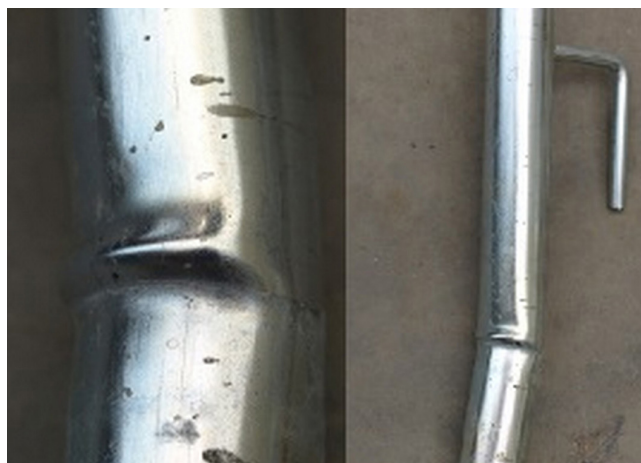
Figure 12. Reduction of the resistance moment of a vertical post due to buckling.

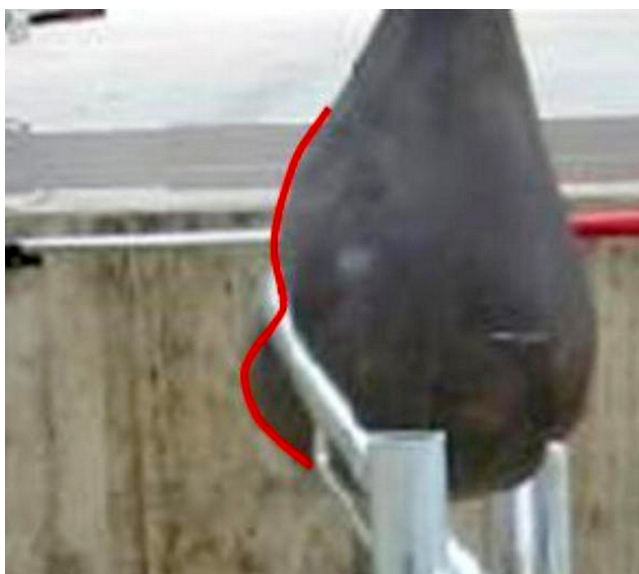
When the impact of the sphericonic ball or the balls of pellets takes place, the object that impacts absorbs a large part of the impact energy rather than the resistant structure. The photograph in Figure 13 shows deformation of the sphericonic ball during the impact and, when the balls of pellets impact, they are partially deformed adopting the form of the board that they hit.

Figure 13. Deformation produced in the ball after an impact of 180 J on a TEPS.

An important role is played in the performance of the impact tests on TEPS by the composition of the impactor. In the case of an impact with a sphericonic ball, defined by standard EN 596, an important part of the impact energy is absorbed by the ball. The TEPS is able to resist the impact but does not absorb 180 J, as is evident from the static tests conducted on the vertical posts. It may be confirmed from the deflection of the vertical posts in the impact test that the energy the vertical posts actually absorb is below 180 J. The authors believe that the impactor
