Visual analysis and Schmidt rebound hammer test of Taj-ul-Masajid

A. Hussain (*), S. Akhtar (*)

Cómo citar este artículo/Citation: Hussain, A., Akhtar, S. (2017). Visual analysis and Schmidt rebound hammer test of Taj-Ul-Masajid. *Informes de la Construcción*, 69(547): e210, doi: <http://dx.doi.org/10.3989/ic.15.097>.

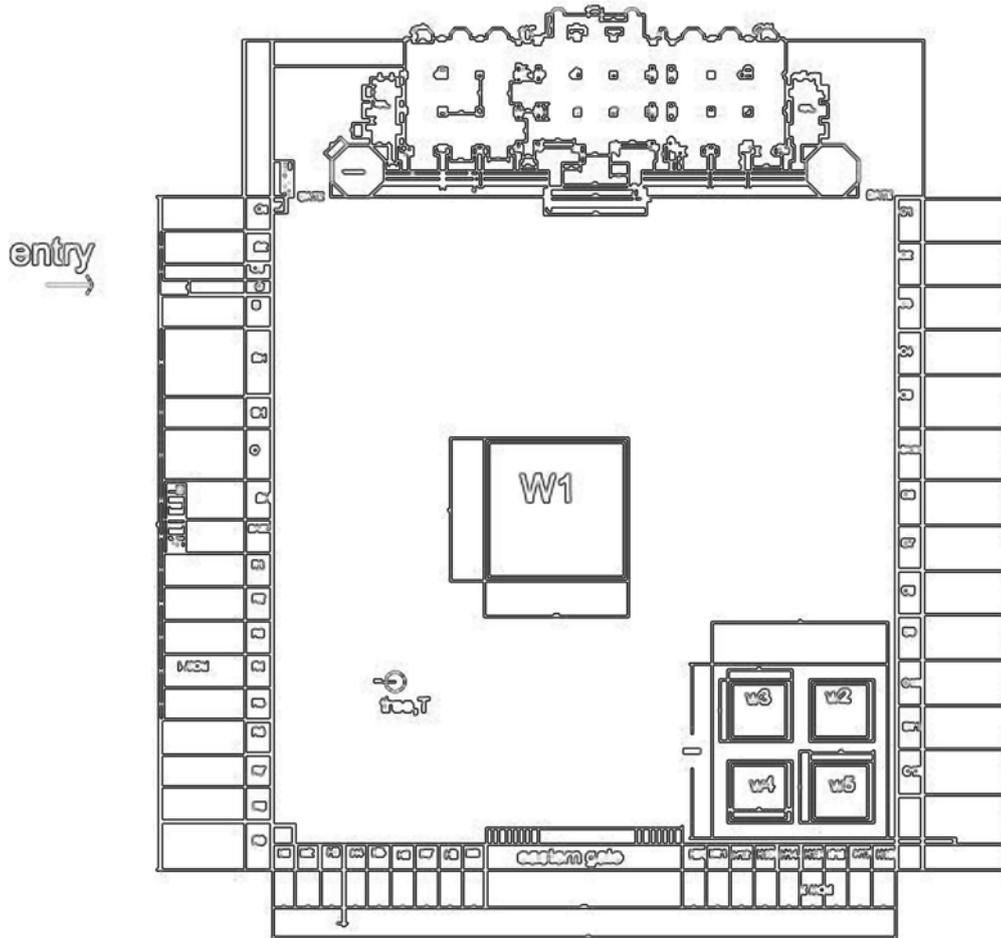
Figure 2. Ground Floor Plan.

The ground floor Plan of the structure is shown in Figure 2.

- Extension from East to West: 526 feet.
- Courtyard: 325 × 325 feet.
- Main Prayer Hall: 72 × 206 feet.
- 3 main gates along the boundary.
- Eastern Gate: 47 ft height, 40 ft width and 40 ft length.
- Northern Gate: 25 ft height, 25 ft width and 18 ft length.
- Southern Gate: 25 ft height, 25ft width and 18ft length.
- Women's Prayer Hall on both the sides.
- Inner courtyard has rooms.
- No of rooms: 120.
- Each measures: 8.5 × 13 feet.

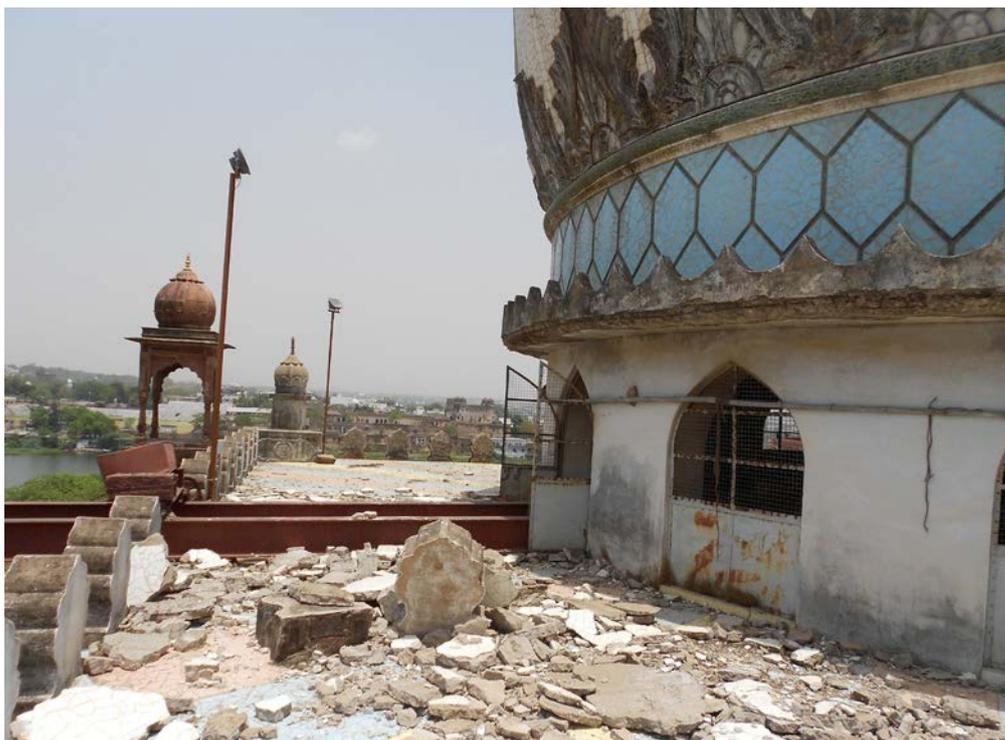
The most severely damaged portion, the amount of damage witnessed in this portion can be made out from Figures 3 and 4. Dampness, Elastic Deformation, cracking, carbonation, chloride attack, sulphate attack, erosion, stone chipping, complete deterioration, and the structure was subject to every imaginable form of damage. The dome closest to the Motia Talab, Dome C, was the most severely damaged. The

rebound number values for this dome were found to be the lowest, as is discussed in the following section. This dome, therefore, needs special consideration.

Figure 3. Dome C.

The dome C showed lower values of rebound number as compared to dome A. The number of immediately vulnerable portions was high. The structure, it could be deduced, is in imme-

diately need of retrofitting. The presence of weak zones indicates the possibility of failure of the structure through these points.

- The Dome C of the structure is in a severely dilapidated condition and may even fall off entirely in the near future, in case the proper retrofitting techniques are not applied.
- Among the three domes, Dome B seems to be the least affected. The minarets which were built before the domes seem unaffected. This indicates a severe case of external environment deteriorating the structure.
- The presence of weak zones in the structure is alarming as the structure may fail through these points.
- The non-uniformity of strong zones, which should've exhibited the presence of steel, shows that the RCC work was done rather arbitrarily than based on a process.

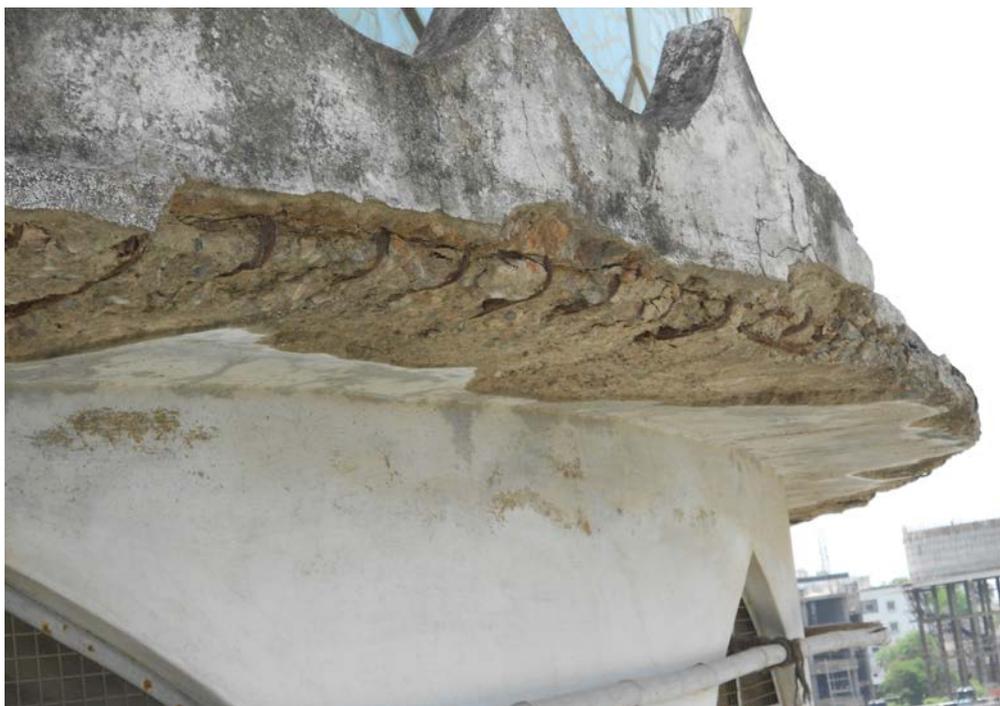
Figure 4. Reinforcement Completely Exposed to External Environment in Dome C.
