Structural appraisal of climate-induced effects on E. Torroja's unreinforced brickwork shell structure of the IETcc winter garden

O. Río (*), D. Theodossopoulos (**)

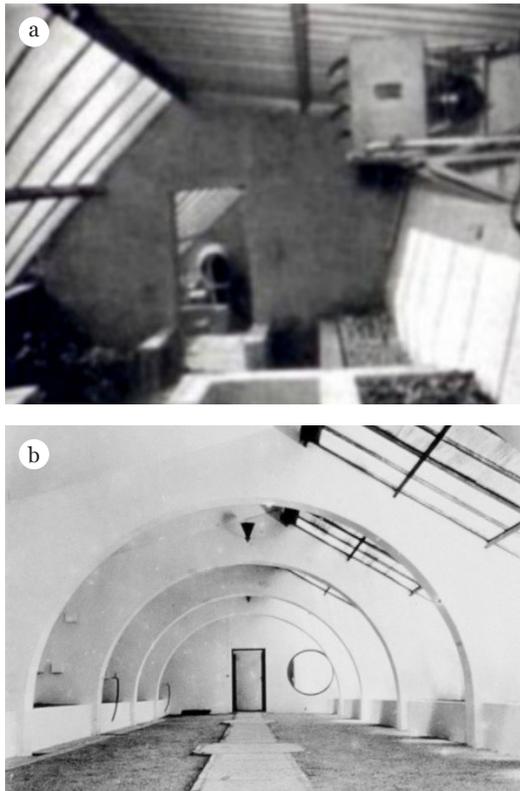
The current building (Figure 3b) replaces a previous one (Figure 3a) located on the site and it is the one that the *Informes de la Construcción* No. 58 mentions as part of the heating installation of the newly built IETcc (4). After construction, the building performed its function for some time.

Figure 3. a) previous winter garden (12),
b) actual winter garden in 1955 (4).

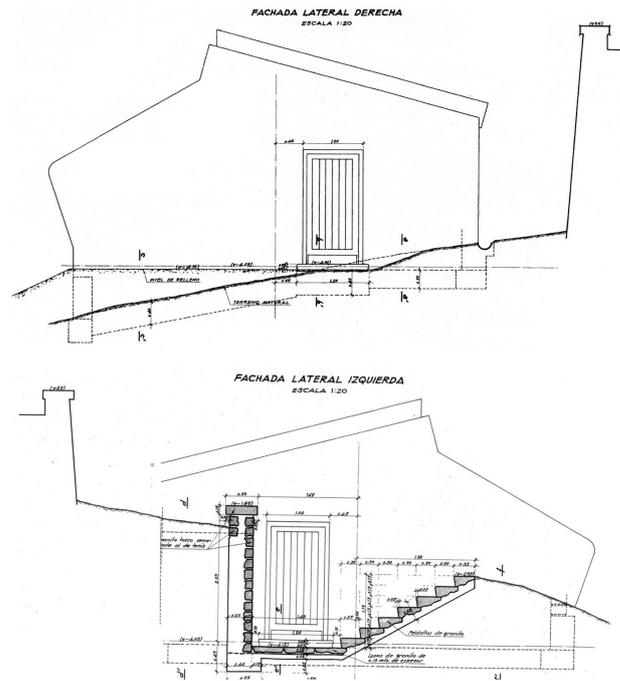
The Winter Garden building is situated close to the tennis court wall coping, over a sloped bed partially filled on the south-east (Figure 2 and Figure 5). It is formed by a main space of six modules of 5,08 m × 7,05 m and two anterooms (Figure 2) of similar area. The whole area is covered by eight shallow barrel vaults leaning towards north and a glass structure leaning to the south. The main space forms an open-plan with planting beds along the longitudinal edge,

Figure 5. Level of earth between West and East façades of actual winter garden as it is shown in the original IETcc plans (4).

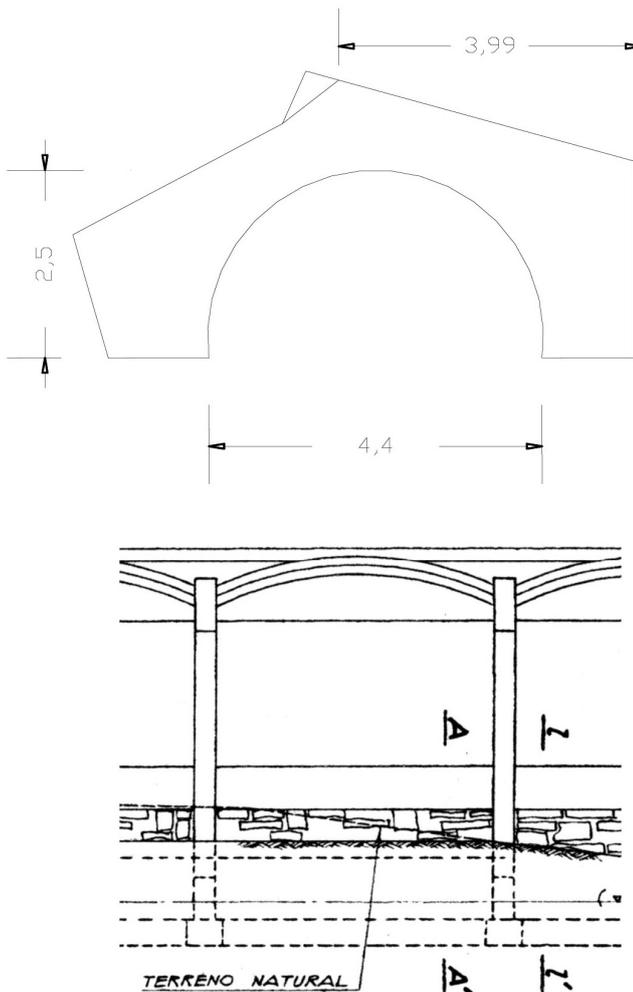
All the structural elements (vaults and arcades) as well as the walls were made of a single leaf of unreinforced brickwork, a quite exceptional application by Torroja (8) (13), and then rendered with a trowel applied cement screed. Each arch has a circular profile, of a 4.4 m span and 2.5 m rise (Figure 6), springing from deep returns on the walls. The thickness of the arch and return is 0.25 m.

The arches support a series of shallow brickwork vaults with a clear span $L = 3.08$ m and a rise $F = 0.4$ m ($L/F = 7.7$), which slope 15° towards the back (Figure 6). The vaults roof the colder North side of the building while the vital daylight enters from the glazed South face (Figures 1). Not much information has been provided on structural reinforcement of the masonry or the connections between the elements (Figures 2 and 5). They were also rendered with cement and no sheeting was applied to cover the roof, with the slope expected to discharge rainwater to gutters at the back side (Figure 4b). The arches are quite pronounced on the extrados

Figure 6. The geometry of the arches.

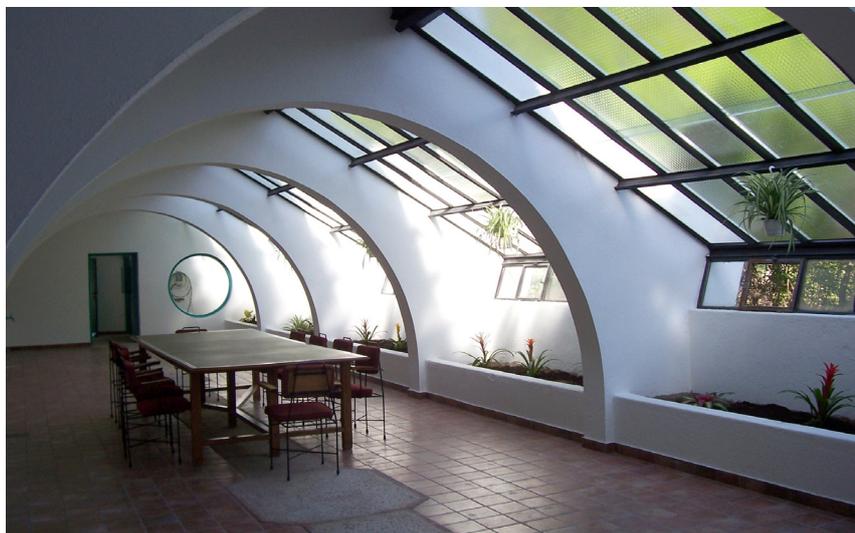
Figure 12. The winter garden after the 2009 refurbishment.

The latter have been probably the main cause for the damage observed following neglect in the last years. The analysis has shown the structural origins of the main cracks observed at the arches and the vault, and justified the repairs that restored the integrity of the building focused on the arch. Further research can be carried out in the exact propagation
